1. Introduction

2. The threat of soil erosion in the servitude.

The purpose of this guideline is to highlight the need for the control of erosion in Transmission servitudes and to introduce alternative methods for the prevention of erosion.

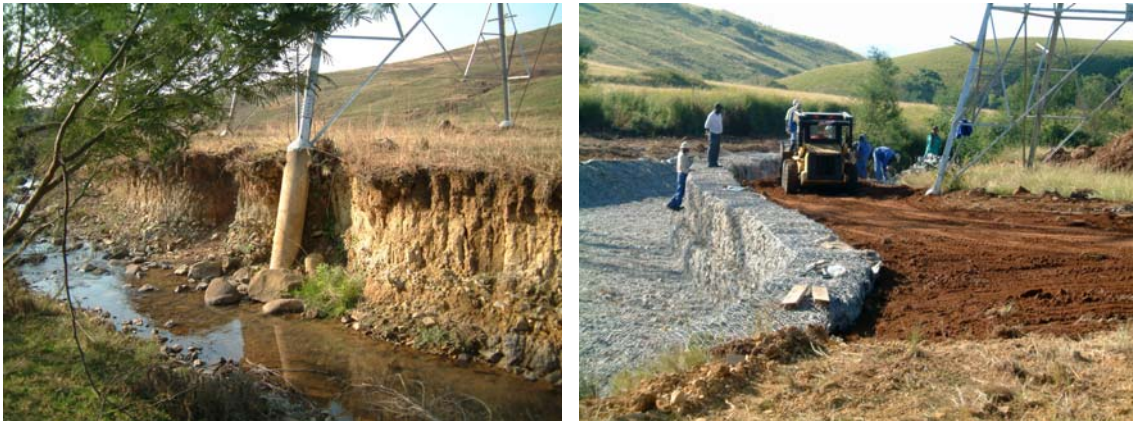
Figure 1: The photo on the left shows the foundation of a tower exposed by erosion. The photo on the right shows the extensive and costly remediation by using gabions and reno mattresses. Also note the use of good topsoil that will permit the re-establishment of vegetation around the tower (photos Jorge Correia).

- **Heavy systems:** These solutions include concrete or brick structures and gabions and reno mattresses, etc. (refer to figure 1). Concrete or cement structures can be constructed on solid rock foundation or they could be floating structures. Several publications on the planning and design of these structures are available from the Agricultural Research Council as well as from commercial companies. The choice between gabions and concrete structures depends inter alia on the availability of rocks. Care should be taken not to disturb the environment where rocks are collected as this could result in the creation of new erosion problems.

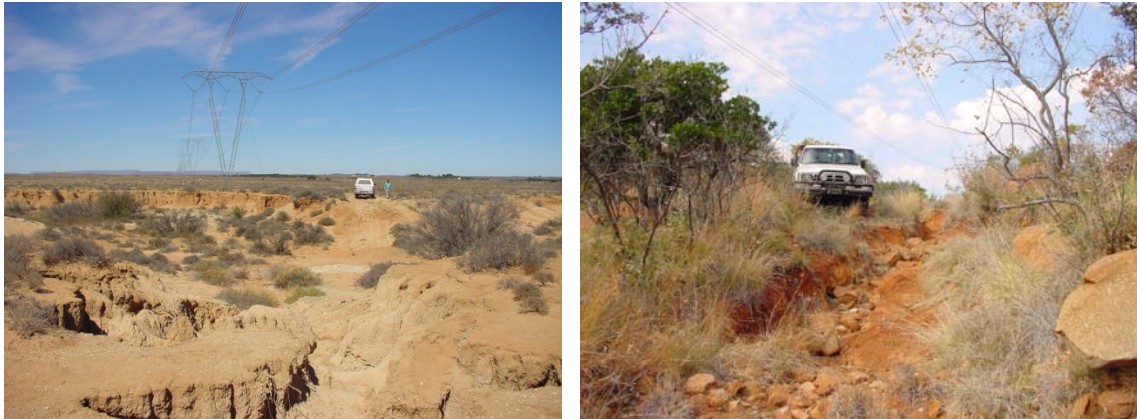
Figure 2. Examples of erosion in the servitude, which hampers access during maintenance and emergencies.

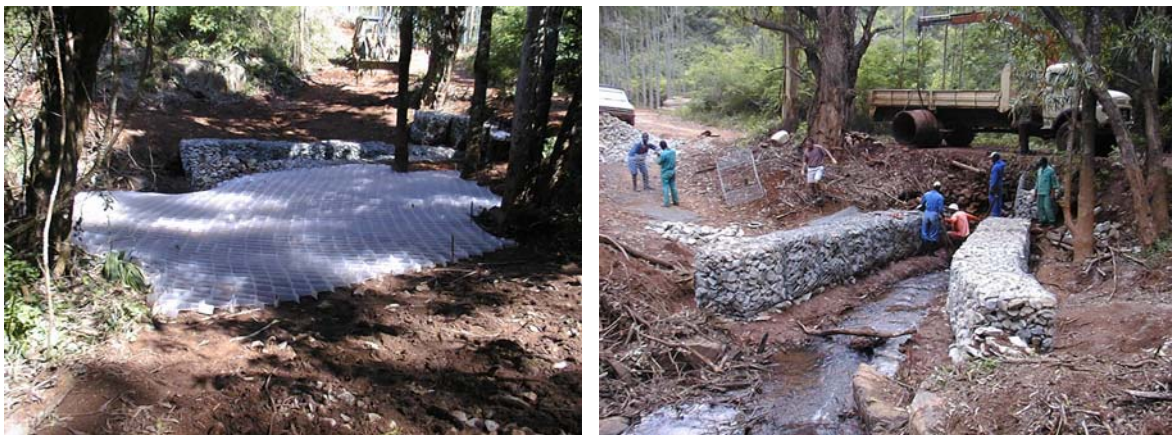
Figure 3. Extensive measures taken to prevent erosion, during the construction of access roads for a new power line. Continuous cellular mat (left) and gabions (right) are some of the measures used during the building of access roads during the construction phase of a power line. (Photos: Jose Clara).

Areas that have highly erodable soils as well as areas in the vicinity of watercourses require special measures as shown above in figure 3 above.

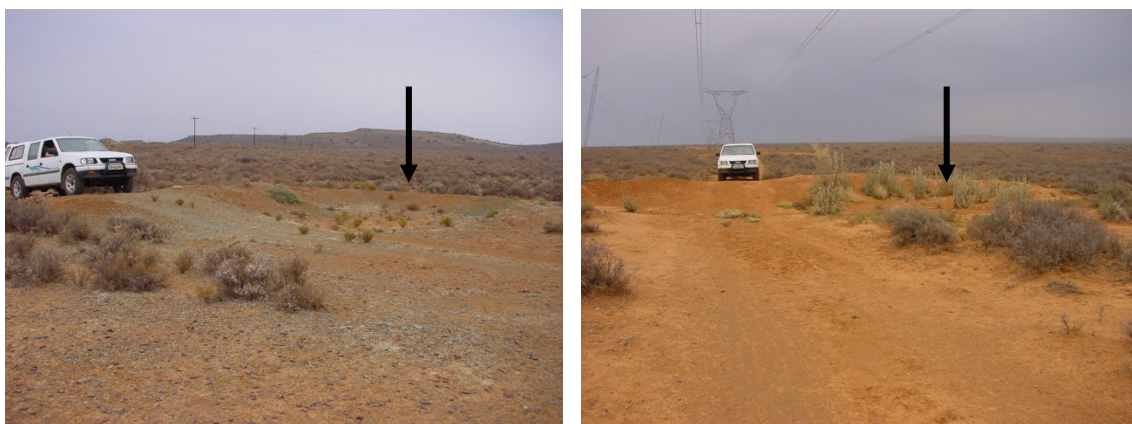
Figure 4. Examples of well constructed berms under the Hydra-Droërivier 1&3 lines. This design uses an overflow dam to spread water collected by the berm (see arrows). After ten years virtually no maintenance is required on these structures.

Regular spacing of berms will prevent the formation of erosion of the access roads. These should be spaced as follows:

Berm spacing (in Metres):

$$\frac{300\text{m}}{\text{Slope of the road (\%)}}$$

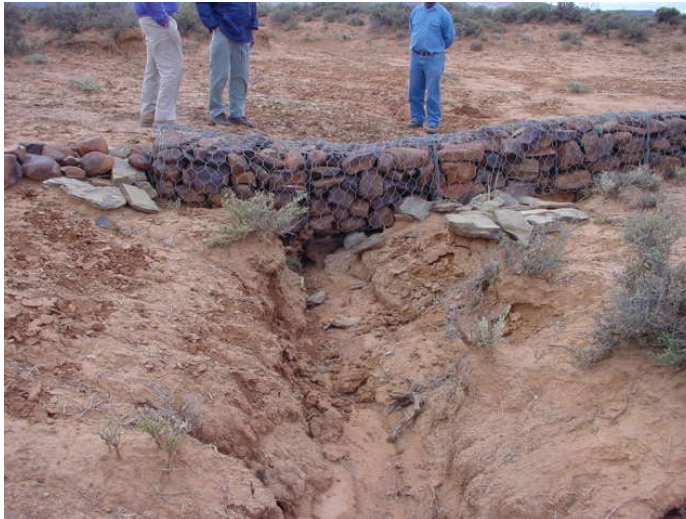
Figure 5. An example of an inappropriately designed gabion. No geotextile or apron was used in this case and erosion eventually occurred under the structure. No provision was made to prevent erosion at the overflow.

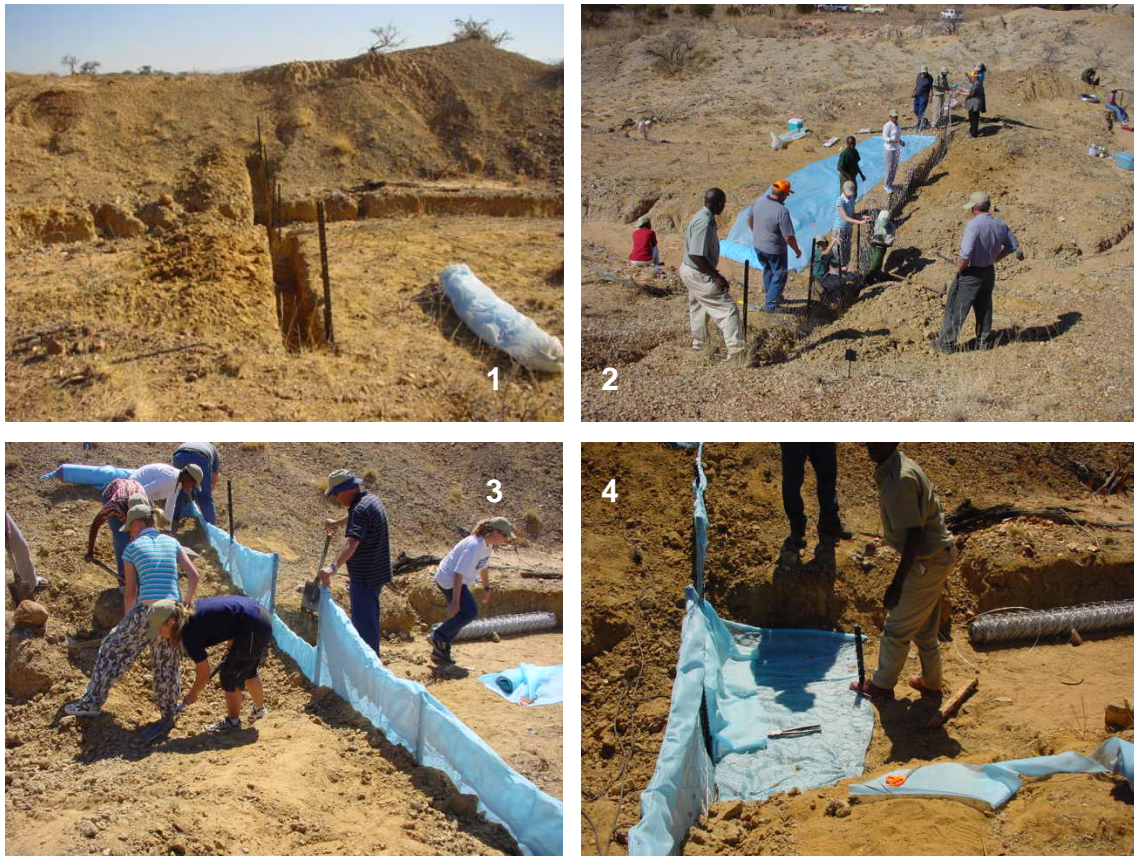
Figure 6 shows the steps in the construction of a silt-screen. Girls from two schools in Pretoria on the Mabula Game farm carried out this exercise. In photo 1 the trench is dug across the erosion channel and Y standards are placed to form the main part of the structure. In photo 2 the Y standards are connected with stay wires and covered with wire mesh. The structure is then covered with a biodegradable geo-textile in photo 3. In photo 4 the structure is completed by adding an apron, made of geo-textile and wire mesh.

The silt-screen is used to trap small particles and seeds, whilst permitting the water to pass through. In this way the fertile trapped soil will permit the re-growth of vegetation and aid the stabilization of the soil. These structures are placed at intervals such that the re-growth of the one structure will reach the overflow of the previous one.

These structures are cheap to construct and the material that is used is a very strong knitted polyethylene, which is biodegradable and will not pollute the environment. The structures are spaced at intervals, which are determined by the slope, vegetation and soils present. (van Heerden 2000, p3-4). A typical design appears in Annexure A

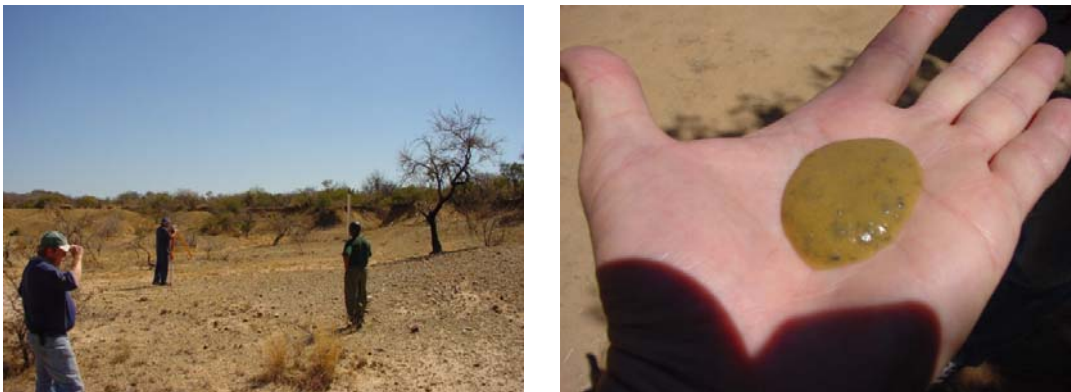
Figure 7. The photo on the left shows an area without topsoil or plant material. The position of the contour is being determined. The photo on the right shows the silicate mineral after water has been added.

Recently, the following procedure was suggested for soil reclamation. A mixture of soil, manure, seeds and a silicate water retardant mineral is mixed and placed in long bags made of a geotextile. These bags are then pinned to the ground, following the contour.

The silicate water retardant will absorb water during rains, but will then retain it for use by the plants during dry spells. Because the geo-textile material is biodegradable, it will decompose with time after the plants have established themselves.

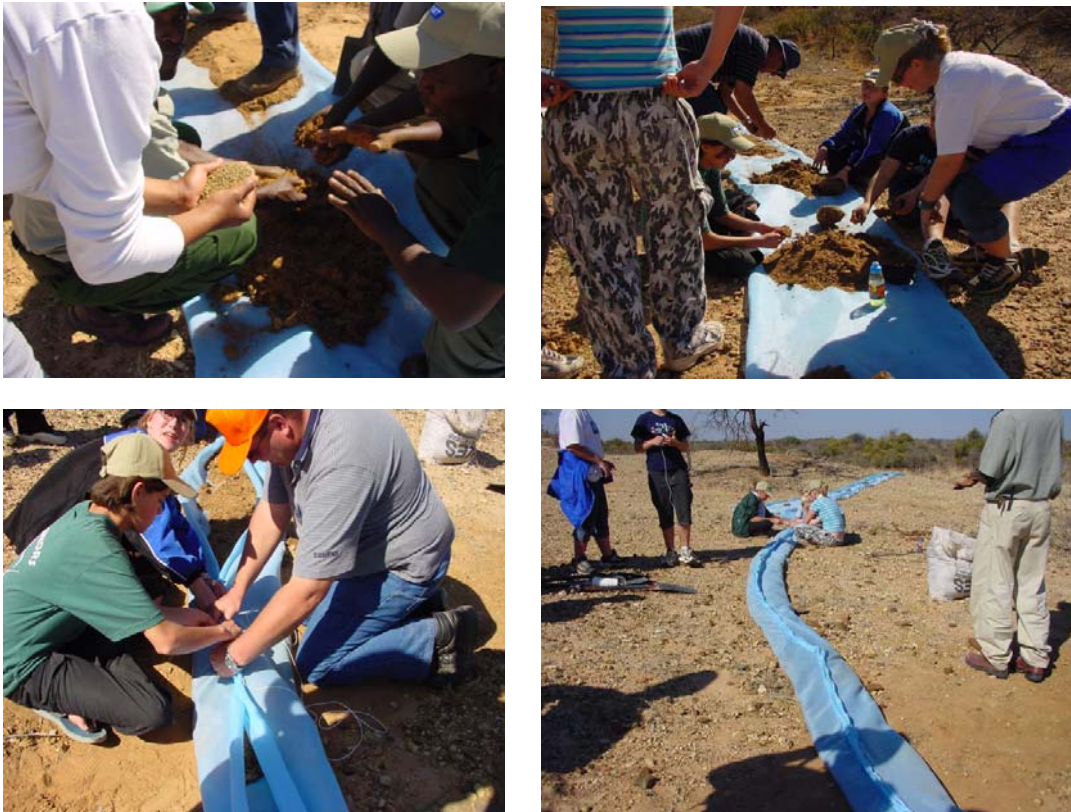
Figure 8. The photo's show the mixing of the soil, the manure seed and silicate mineral before placing it in the geotextile bags.
